**Re: Immediate Response Action Plan Modification No. 7**  
50 Tufts Street  
Somerville, MA  
RTN 3-23246

On behalf of UniFirst Corporation of Wilmington, Massachusetts, we prepared this Immediate Response Action (IRA) Plan Modification No. 7 for the 50 Tufts Street site in Somerville, Massachusetts. This IRA Plan Modification No. 7 addresses activities conducted between August 20, 2007 and September 10, 2007, at the Michael E. Capuano Early Childhood Center (Capuano Center) located at 150 Glen Street in Somerville, Massachusetts. The Massachusetts Department of Environmental Protection (DEP) initially assigned Release Tracking Number (RTN) 3-26114 to the IRA activities associated with the Capuano Center. On July 21, 2007, RTN 3-26114 was linked to the nearby Site at 50 Tufts Street (RTN 3-23246). The Site location is shown in Figure 1 and a Site Plan in Figure 2.

Immediate Response Action Modification No. 7  
 Michael E. Capuano Early Childhood Center  
 Somerville, Massachusetts

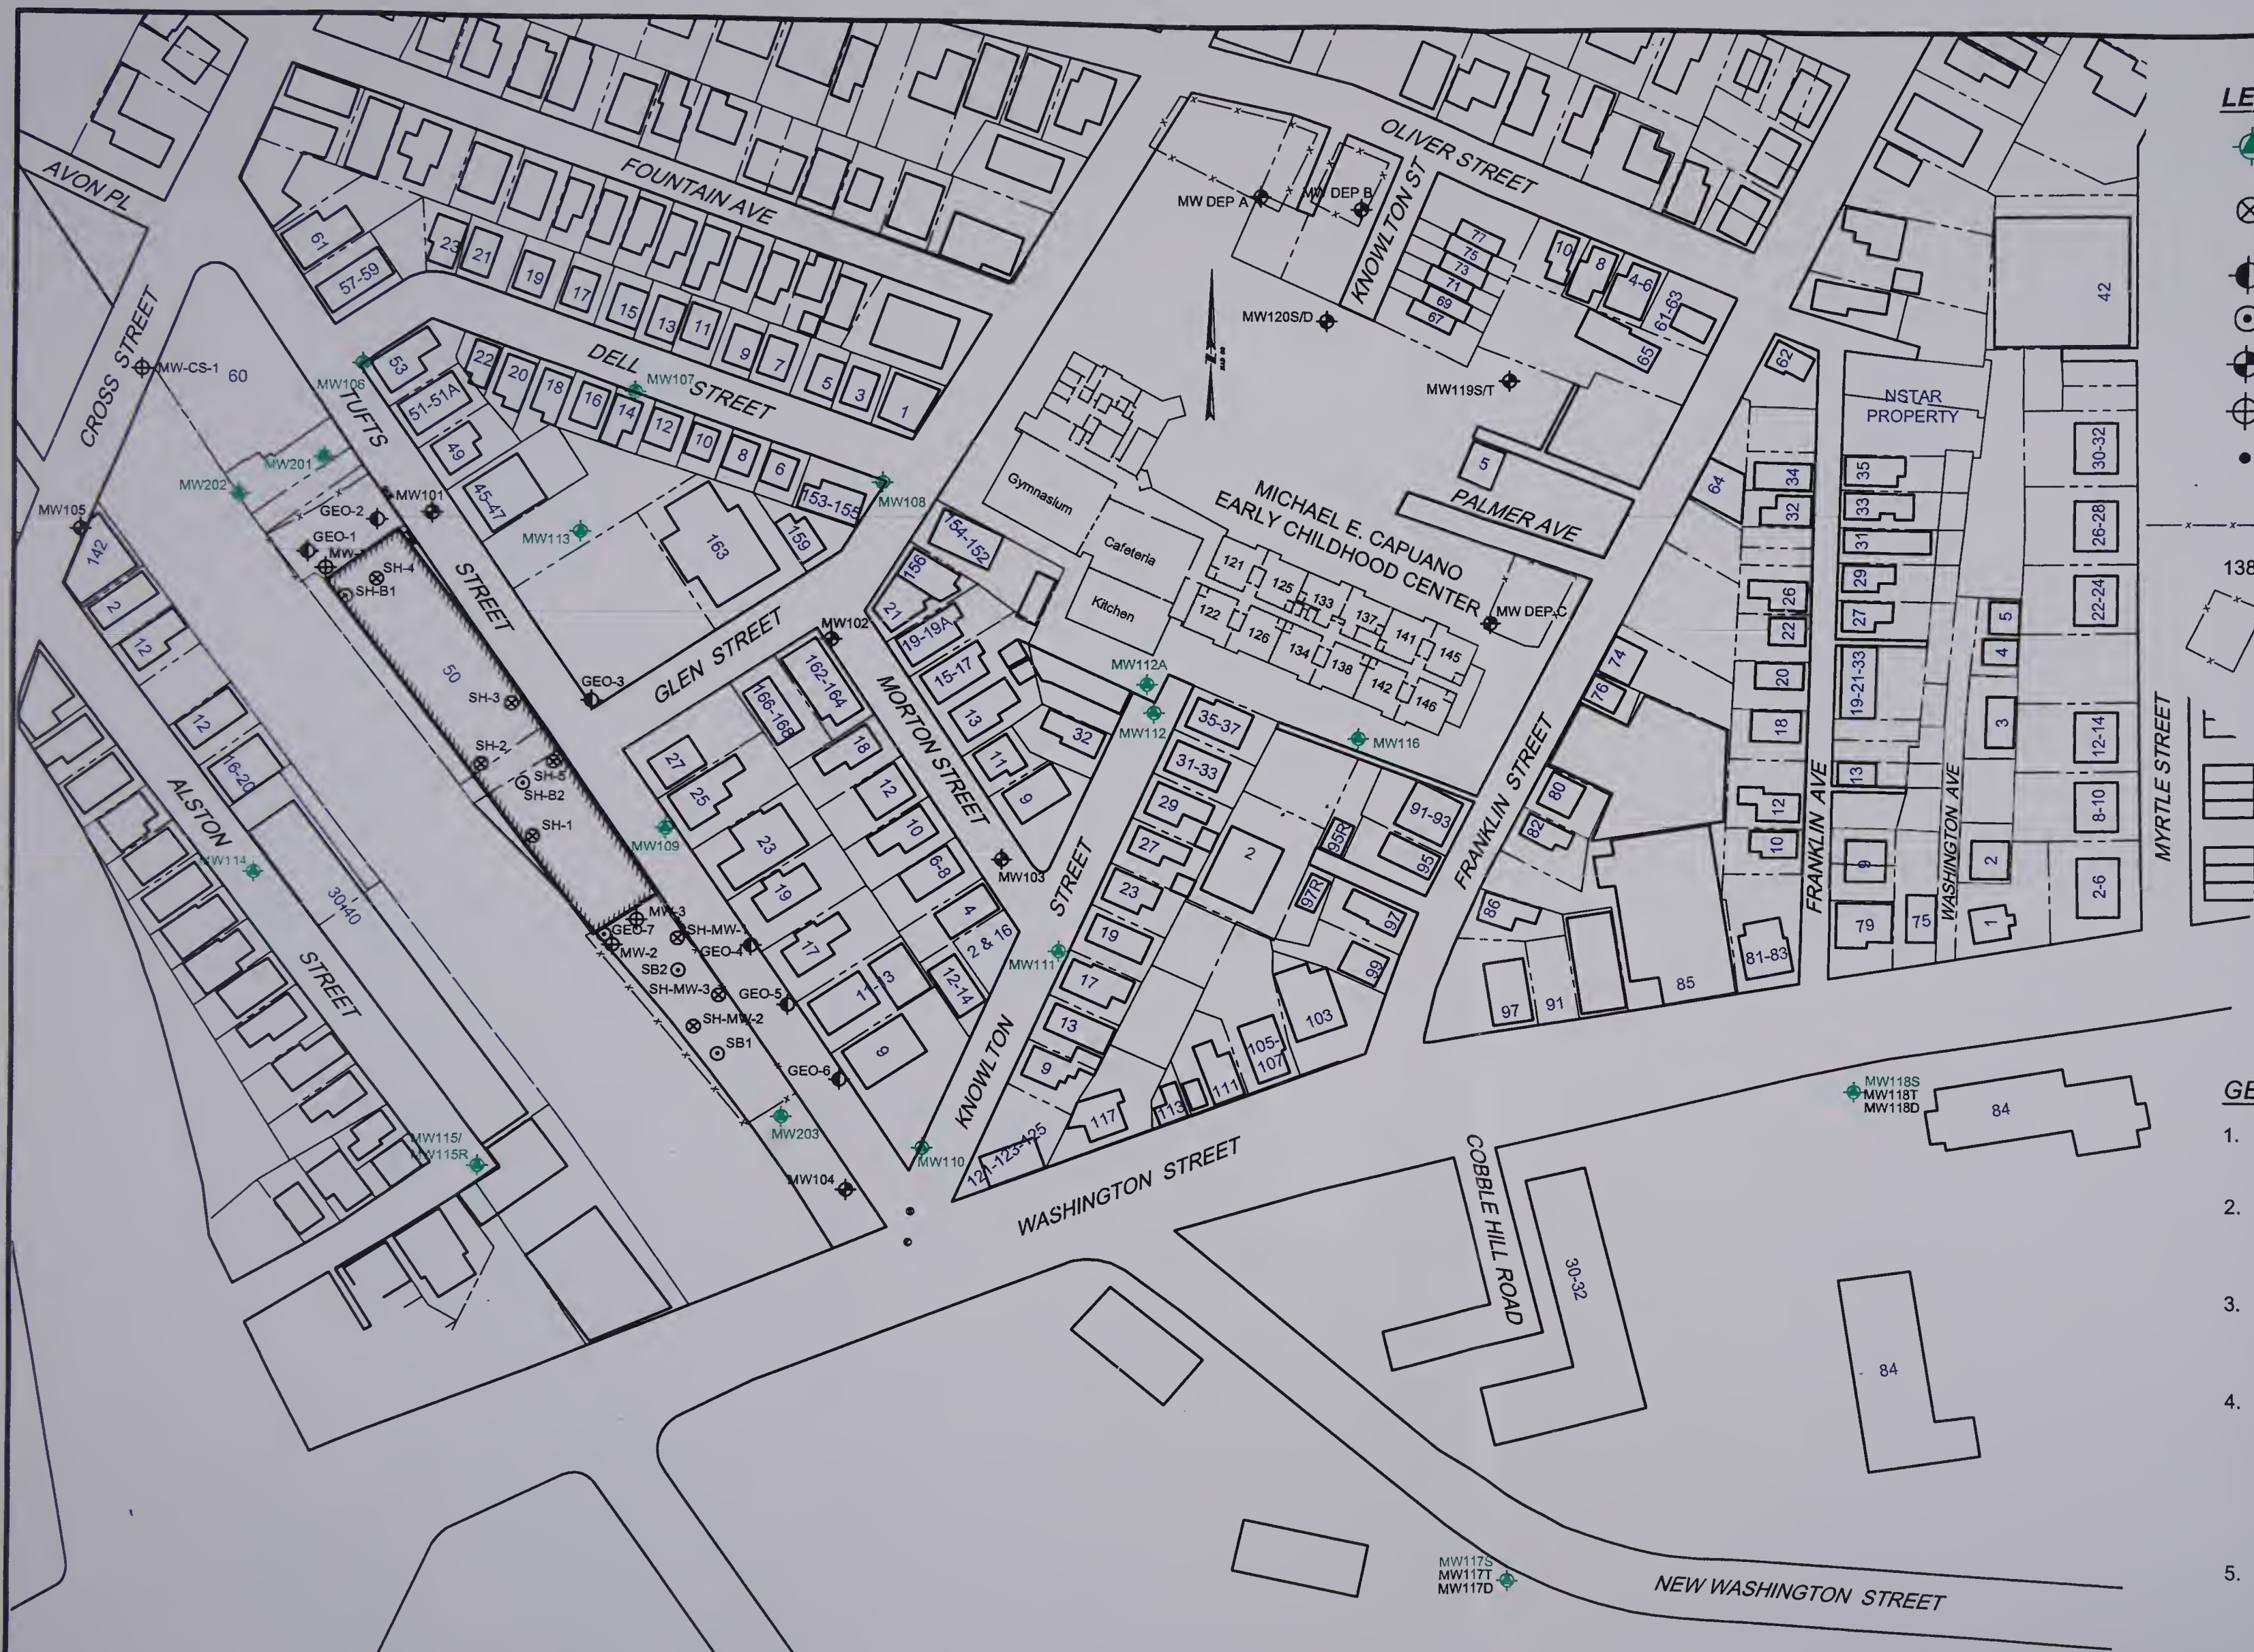
Project 04516-2 October 2007 Fig. 2

SITE PLAN

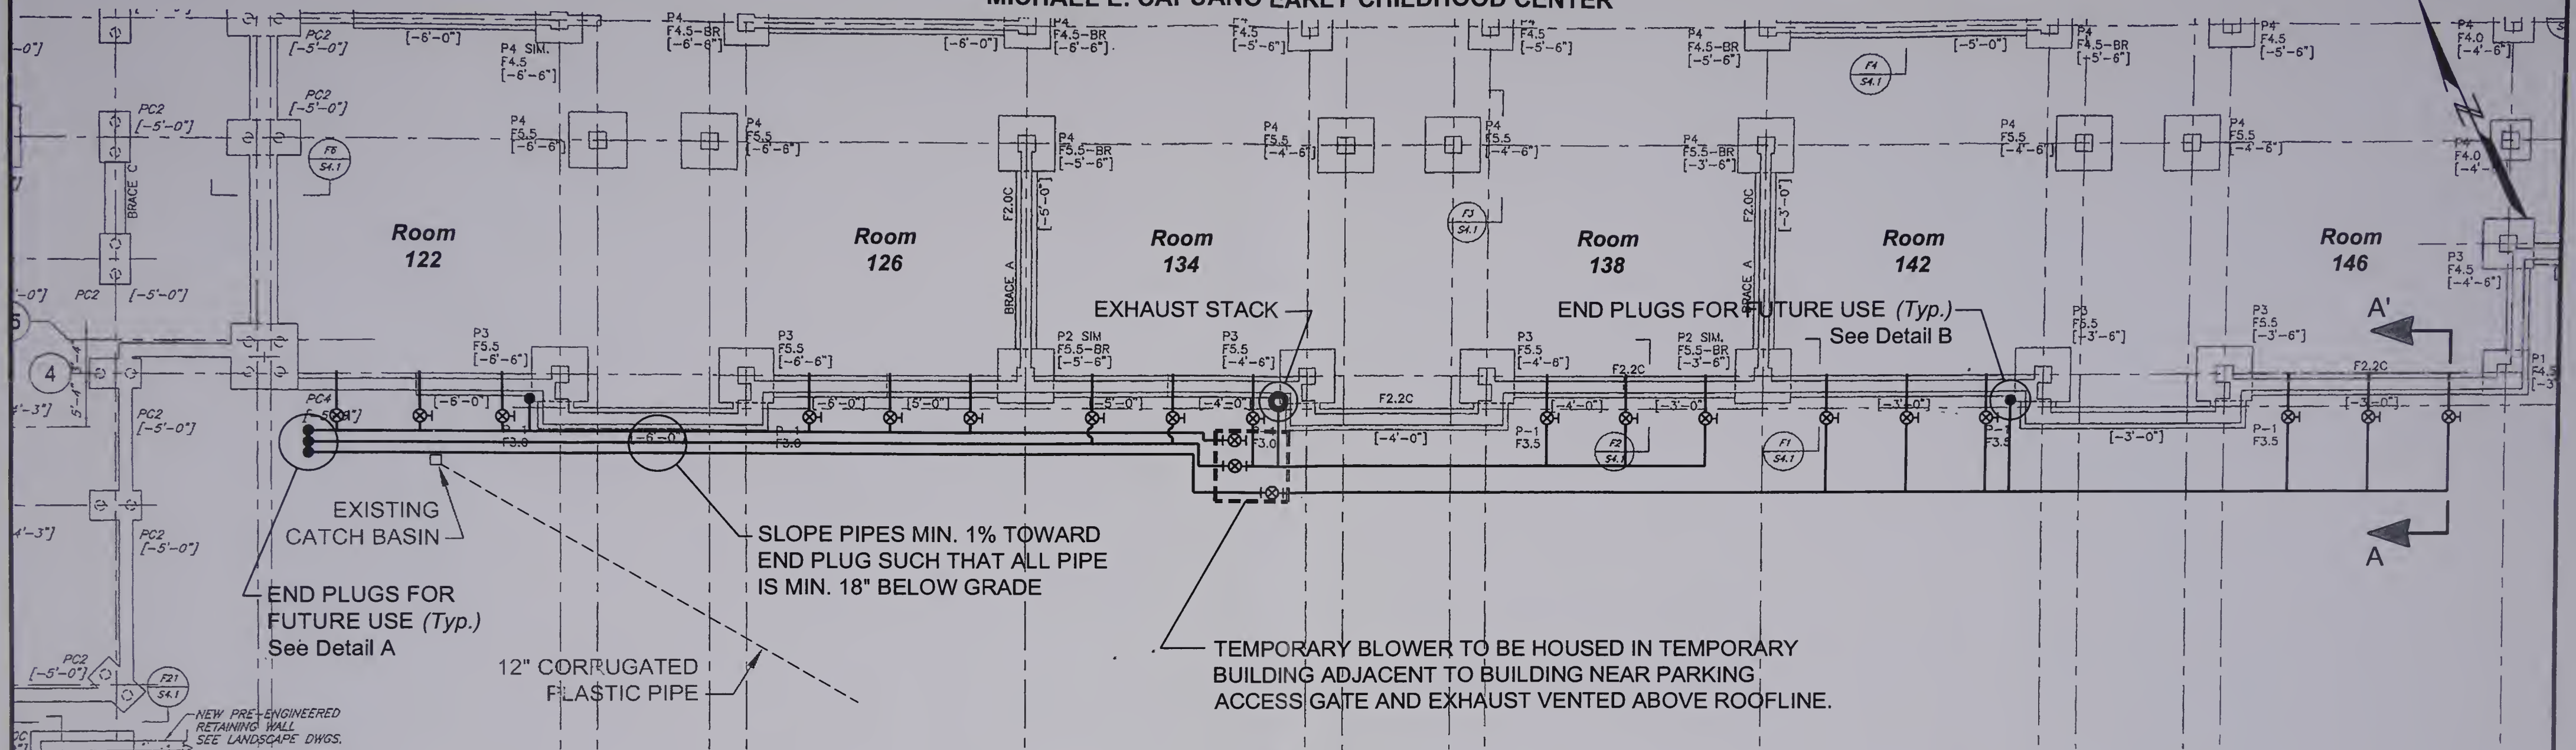
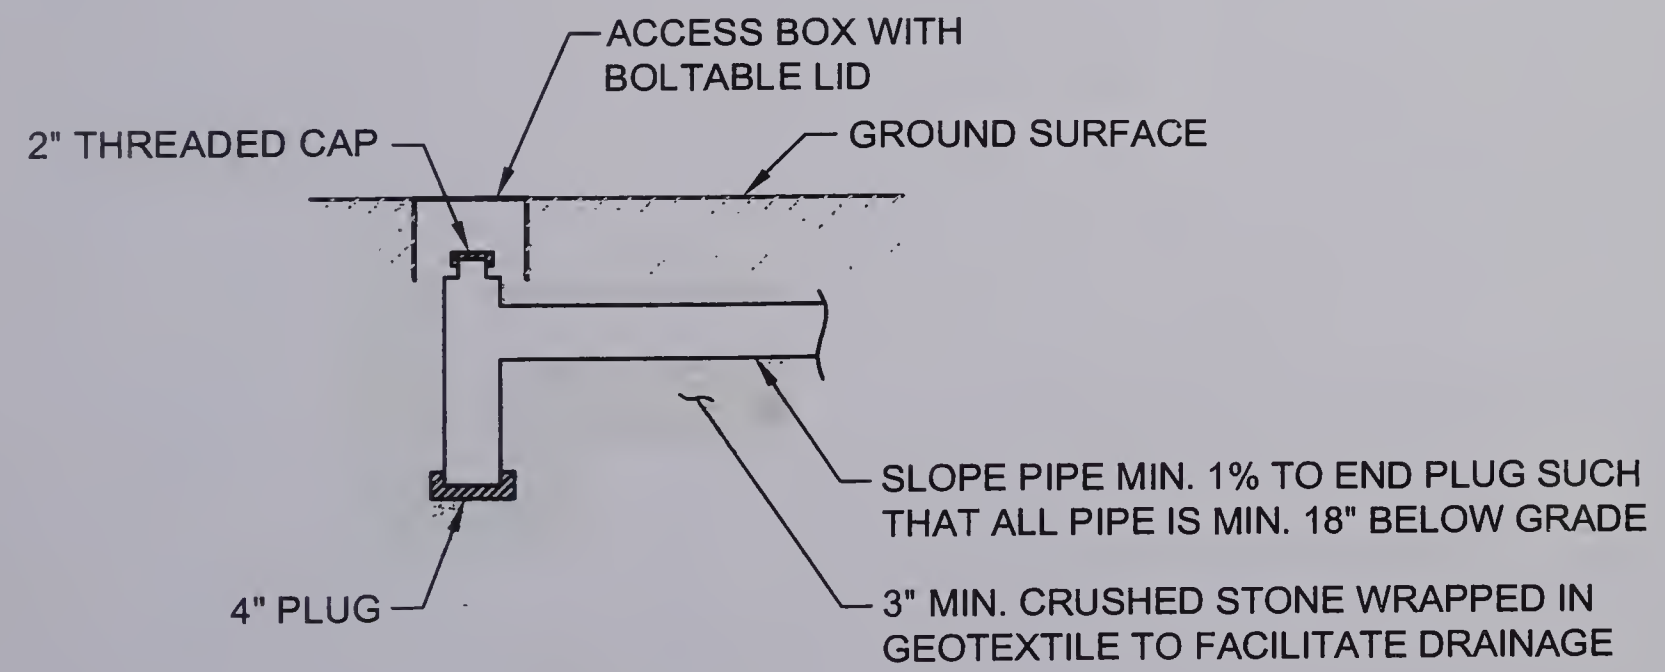
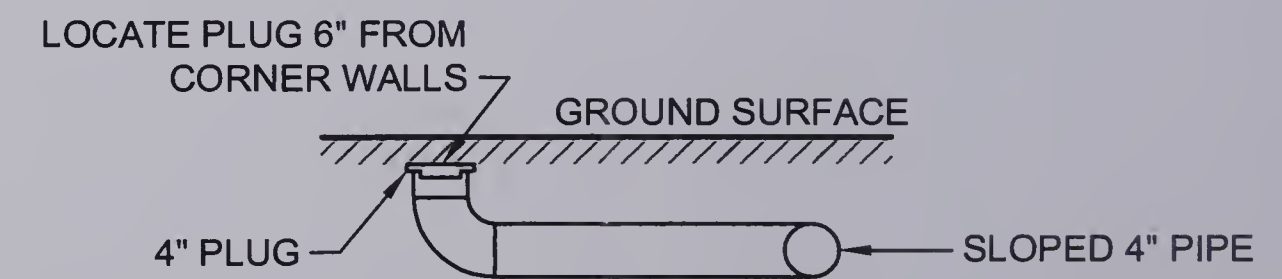
<p>IRA Plan Modification No. 7 Michael E. Capuano Early Childhood Center Somerville, Massachusetts</p>	<p><b>GEI</b> Consultants</p>	<p>SSDS EXTERIOR PIPING SCHEMATIC</p>
<p>UniFirst Corporation Wilmington, Massachusetts</p>	<p>Project 04516-2</p>	<p>October 2007 Fig. 3</p>

**PLAN**  
Not To Scale

**DETAIL A**  
Not To Scale

**DETAIL B**  
Not To Scale

- FOR SECTION A-A SEE FIG. 14.
- BASE PLAN FROM FIGURE TITLED "EDGERLY EARLY CHILDHOOD DEVELOPMENT CENTER SOMERVILLE, MASSACHUSETTS FOUNDATION PLAN - PART B" BY HMFH ARCHITECTS DATED 08/10/2001.
- BASE PLAN HAS BEEN MODIFIED BY GEI TO SHOW THE APPROXIMATE LOCATION OF THE SSDS COMPONENTS

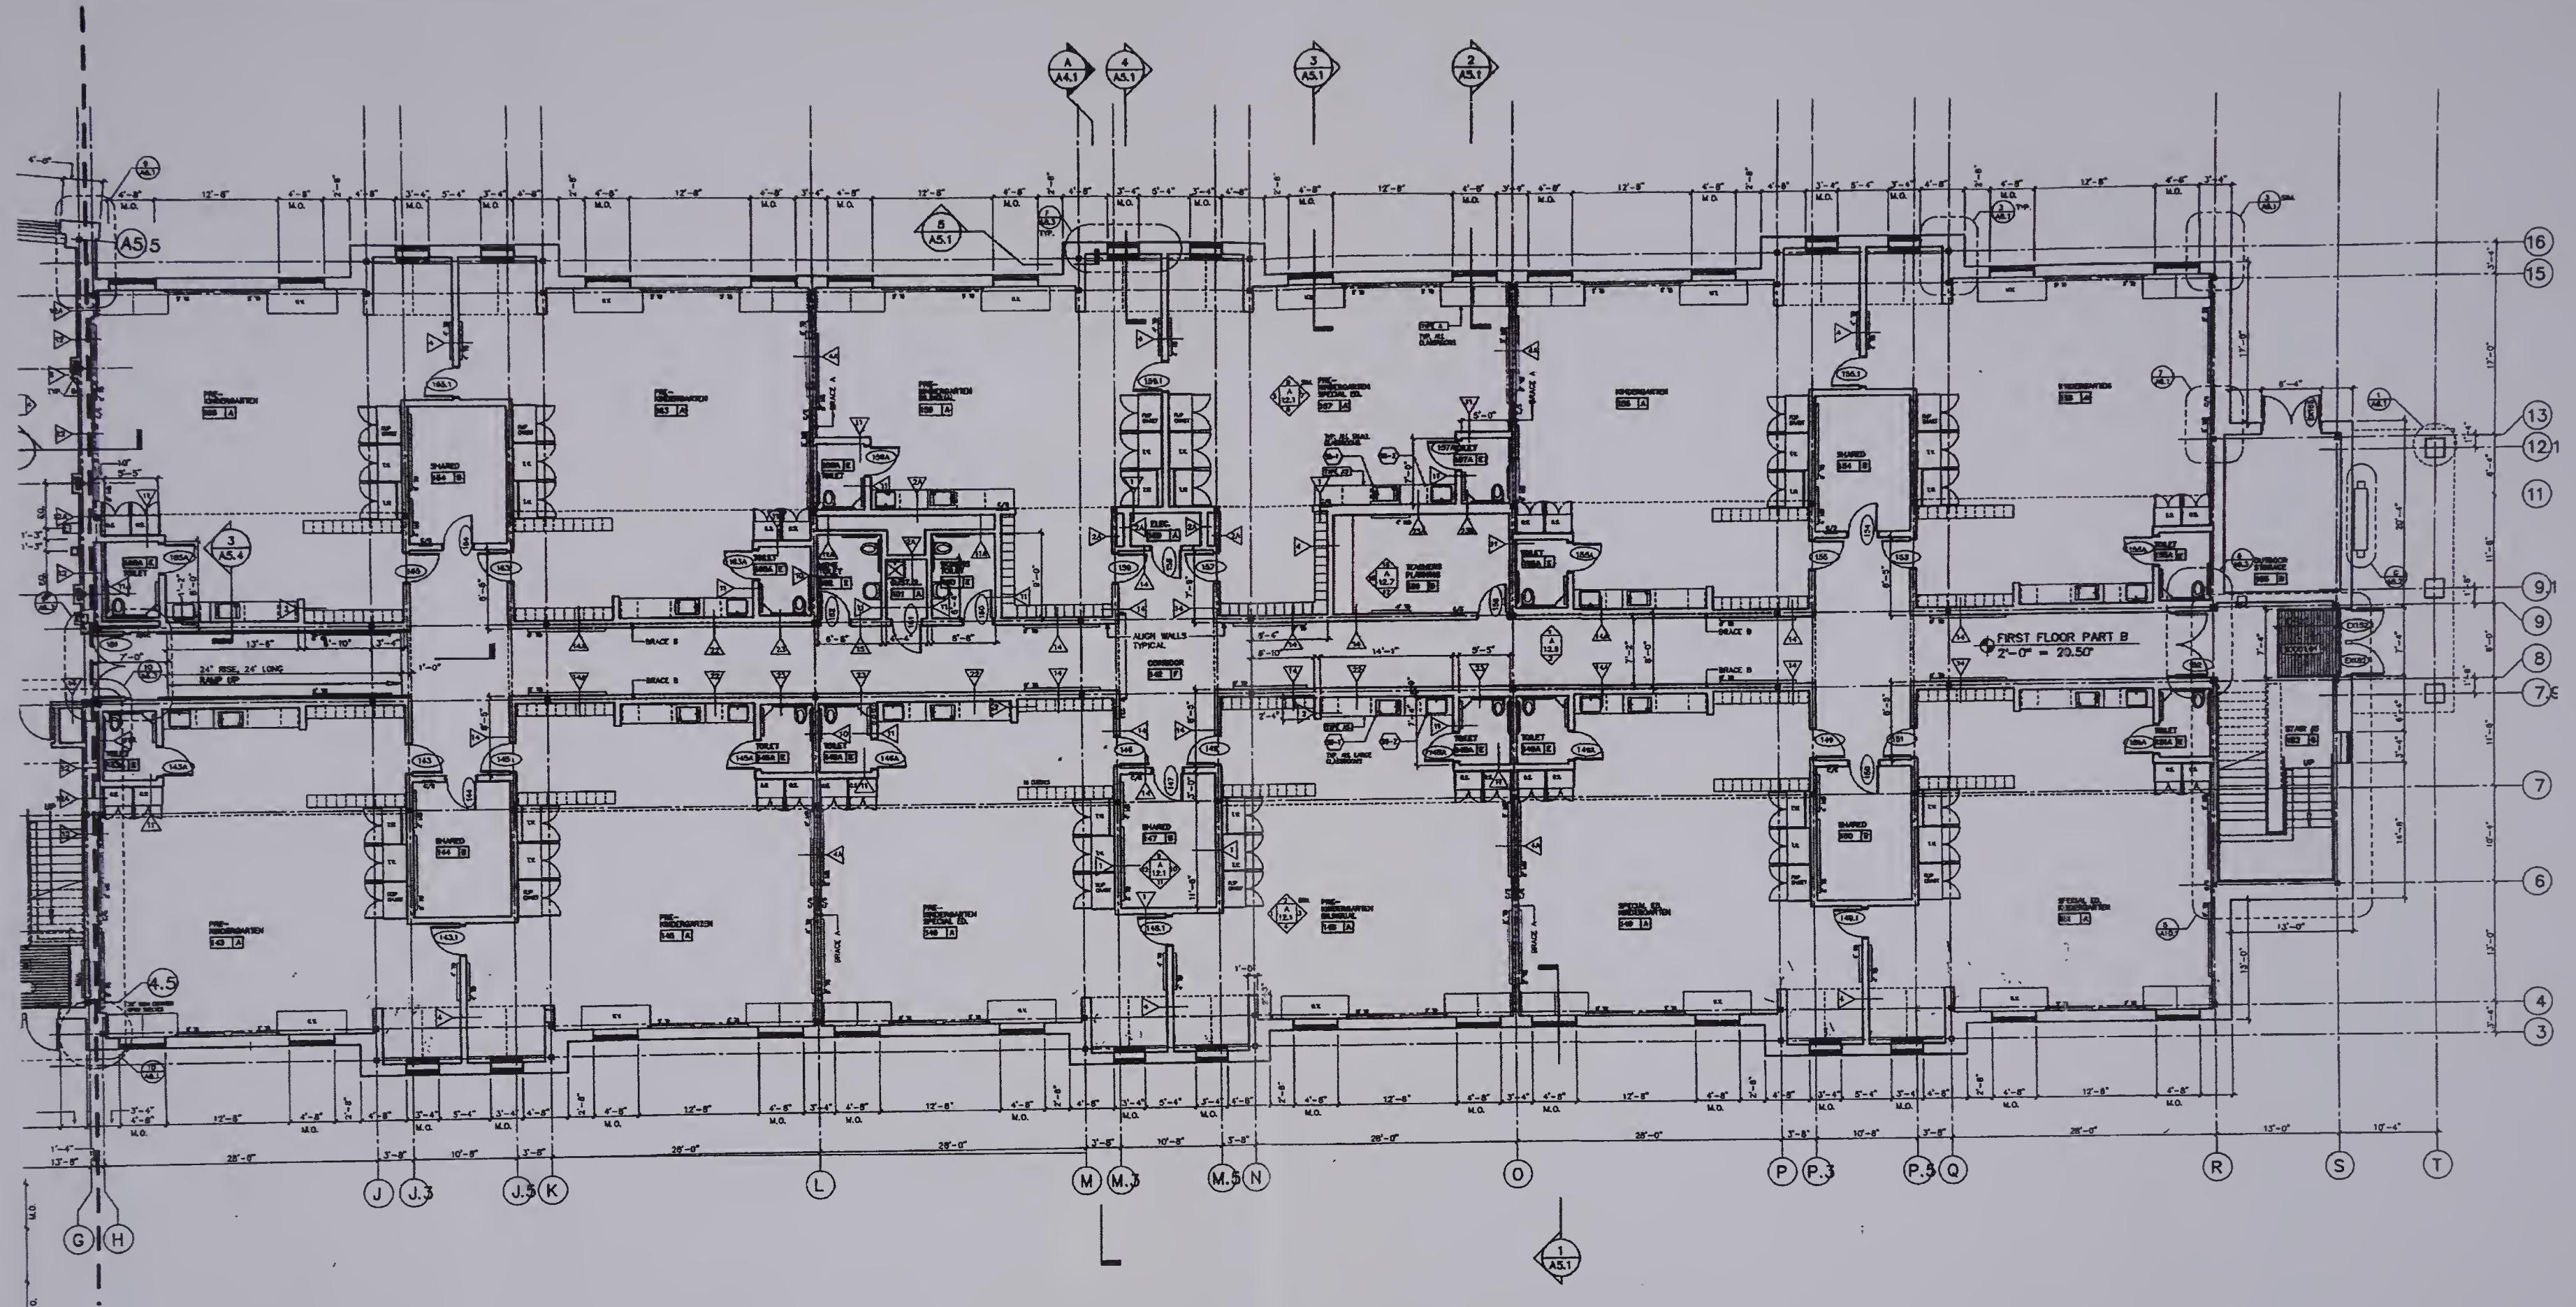
Fig. 4

FIRST FLOOR PLAN - SOUTHERN WING

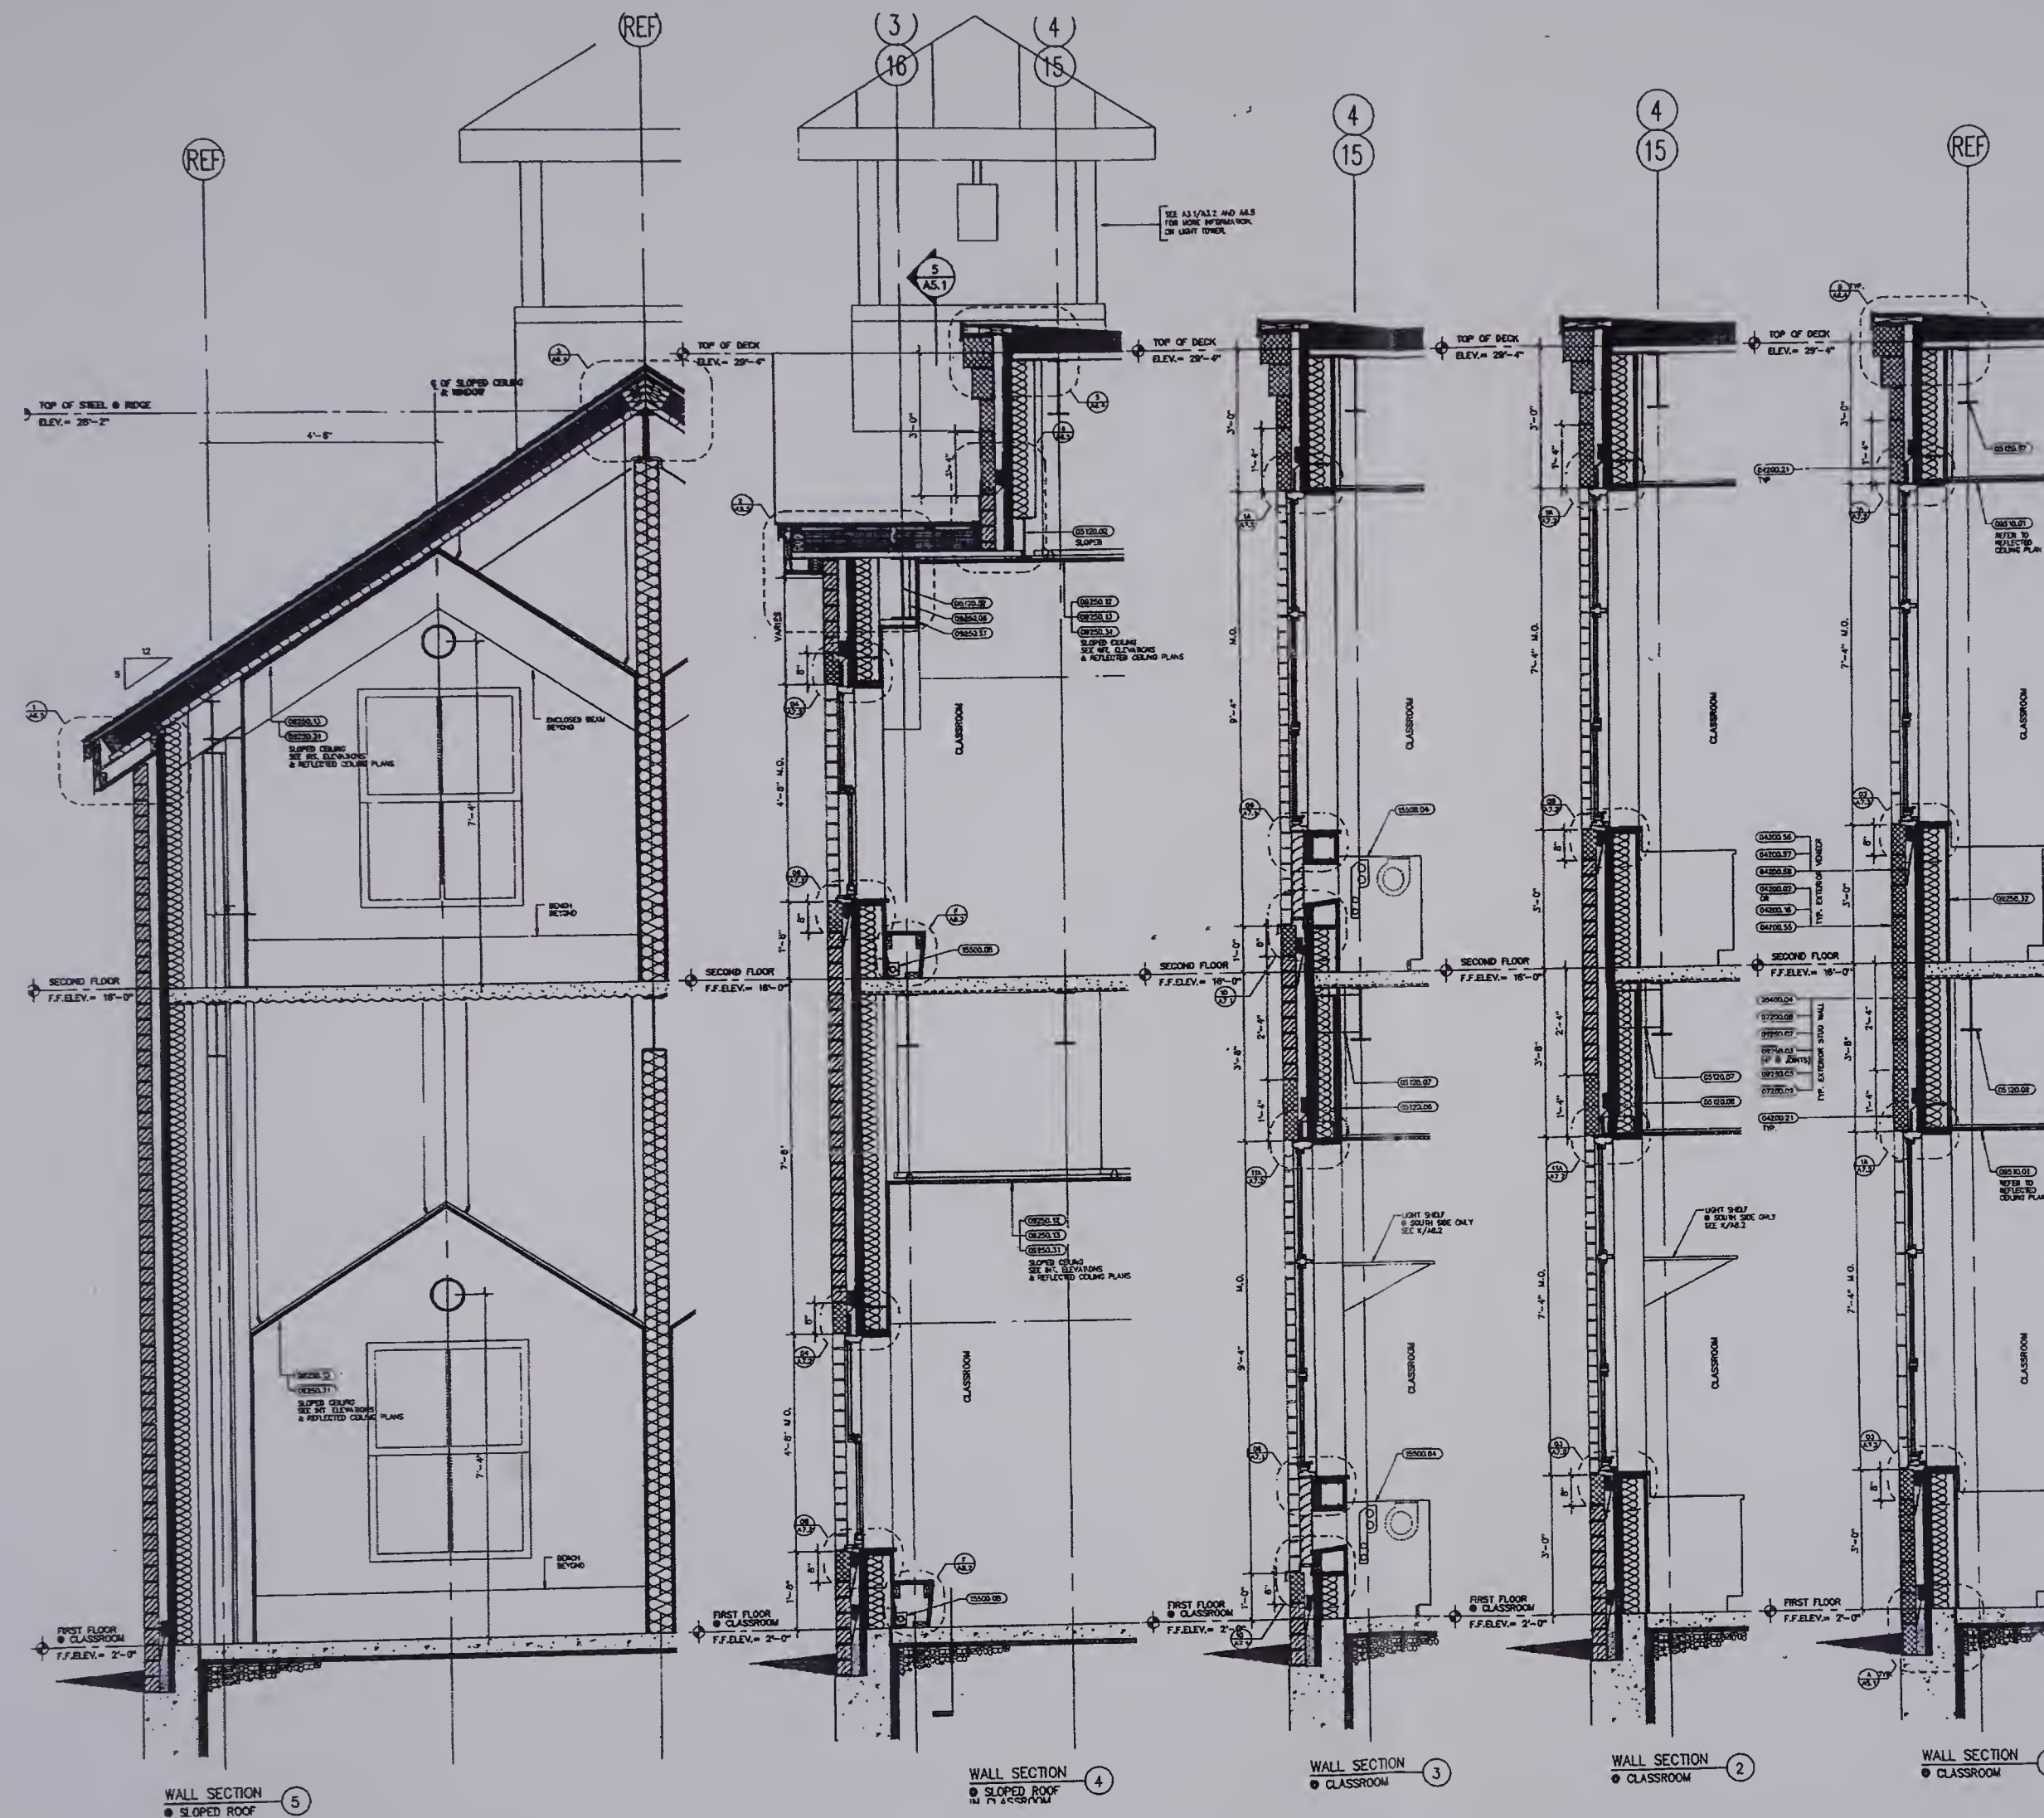
Fig. 5

WALL SECTIONS

- Concrete Restoration applied Phenoseal®, a water-based flexible sealant, to seal the floor slab/foundation wall joint and any additional interior cracks which were greater than 0.125 inch wide. A materials specification sheet for Phenoseal® is in Attachment C. GEI estimates that the total length of these joints and cracks was approximately 80 linear feet. Figure 3 shows a plan of the portion of the building affected by the SSDS and the locations of interior and exterior walls. Figures 4 through 6 shows wall sections and construction details of the foundation slab and walls.

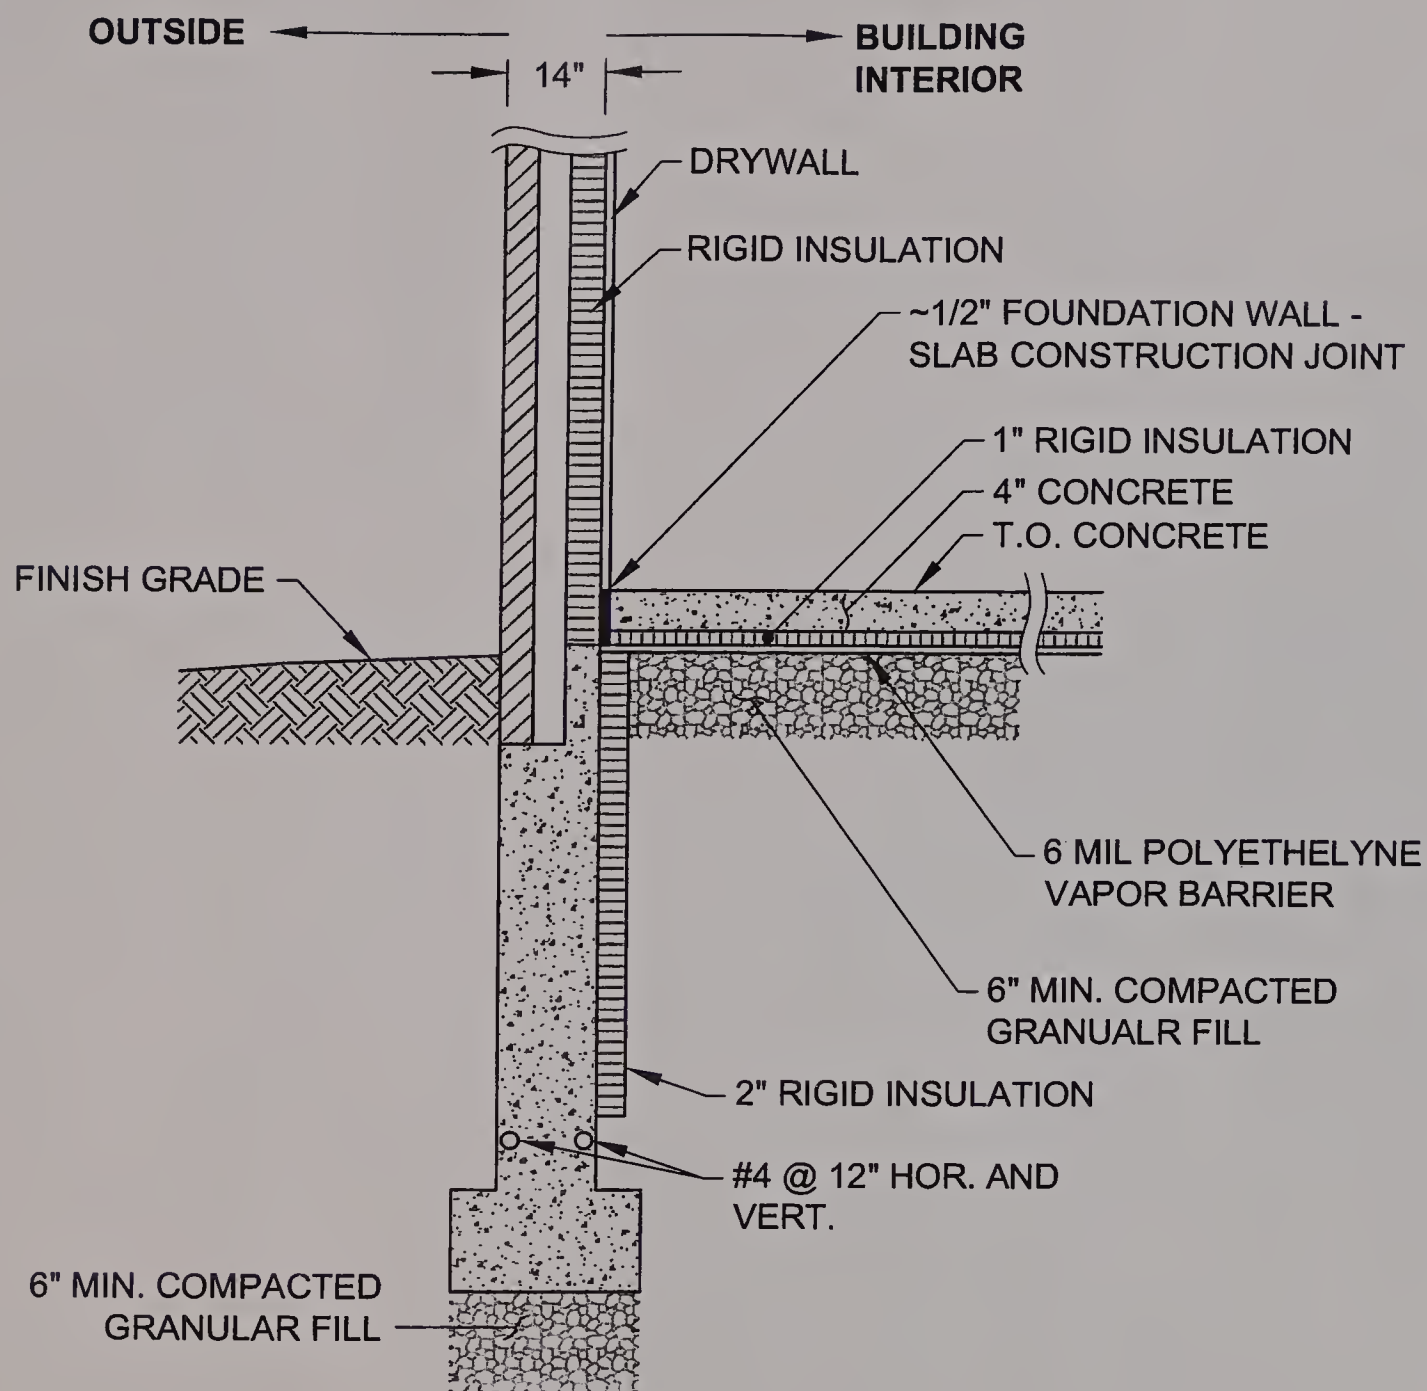
Fig. 6

1. BASE PLAN, MODIFIED BY GEI, FROM FIGURE TITLED "EDGERLY EARLY CHILDHOOD DEVELOPMENT CENTER SOMERVILLE, MASSACHUSETTS FOUNDATION SECTIONS" BY HMFH ARCHITECTS DATED 08/10/2001.

FOUNDATION WALL -  
SLAB CONSTRUCTION  
JOINT DETAIL

- GEI engaged Concrete Restoration of Winchester, Massachusetts to prepare and seal the floor slab/foundation wall joint in six classrooms (Rooms 122, 126, 134, 138, 142, and 146) in the southern wing of the Capuano Center. The joint sections behind the UV in each classroom were already sealed as part of previous IRA activities conducted between January 29, and February 1, 2007.

- Concrete Restoration cleaned, dried, and removed old sealant and surface contaminants (e.g. oil, grease, and foreign matter) from the floor slab/foundation wall joint and surrounding substrate. Concrete Restoration prepared the joints and cracks to provide a sound bonding surface for the sealant. Concrete Restoration removed dust and other particles using oil-free compressed air.

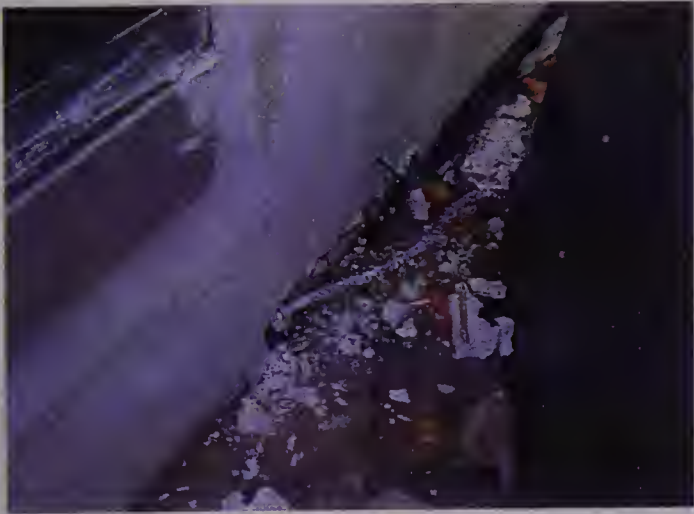
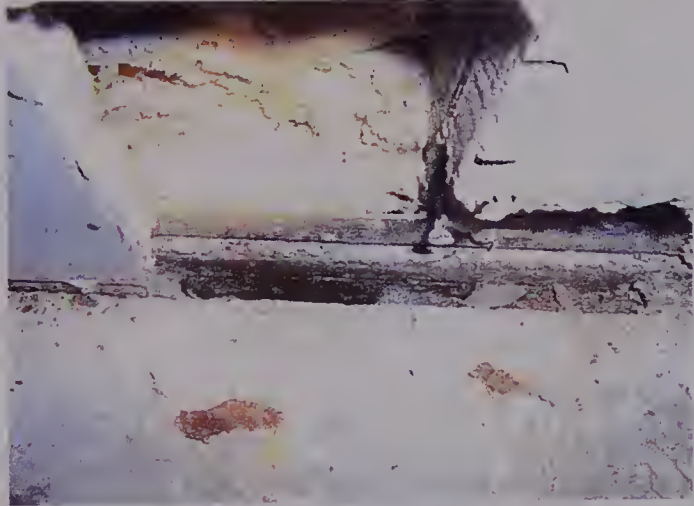
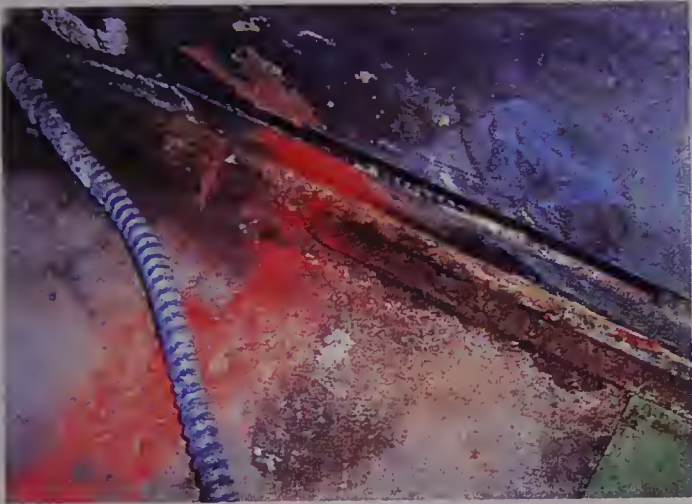
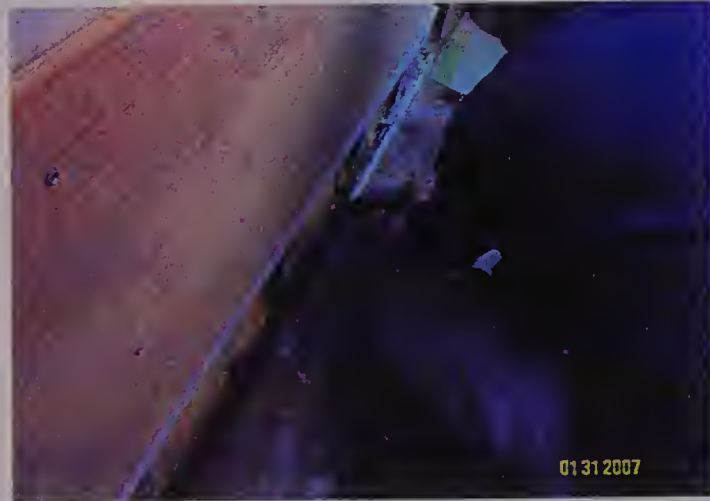
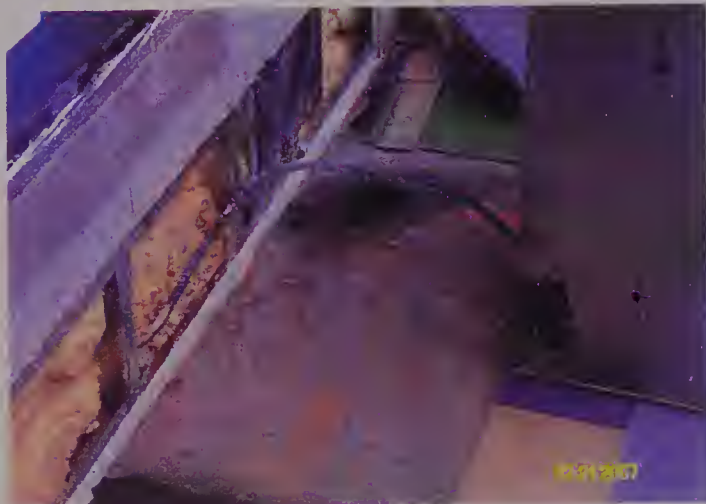
**ATTACHMENT B**  
EH&E Photographs of the Floor Slab/Foundation Wall Joint

The smoke test consisted of introducing artificial non-toxic smoke near the floor slab/foundation wall joint while the SSDS was operating. Migration of smoke was observed from the indoor air into the joint. Photographs of the floor slab/foundation wall joint taken by EH&E during unit ventilator repairs in January 2007 are in Attachment B.

**Michael E. Capuano Early Childhood Center  
Unit Ventilator Sealing: January – February 2007**
